Borough of Haddon Heights
625 Station Avenue
Haddon Heights, NJ 08035

Re: Evaluation of Report for
501 Station Avenue as Prepared by
Leake Engineering LLC
Dated May 12, 2022
Bach Associates No.: HH2023-0

Project Address: 501 Station Ave, Haddon Heights, NJ 08035

Date: 05/12/2022

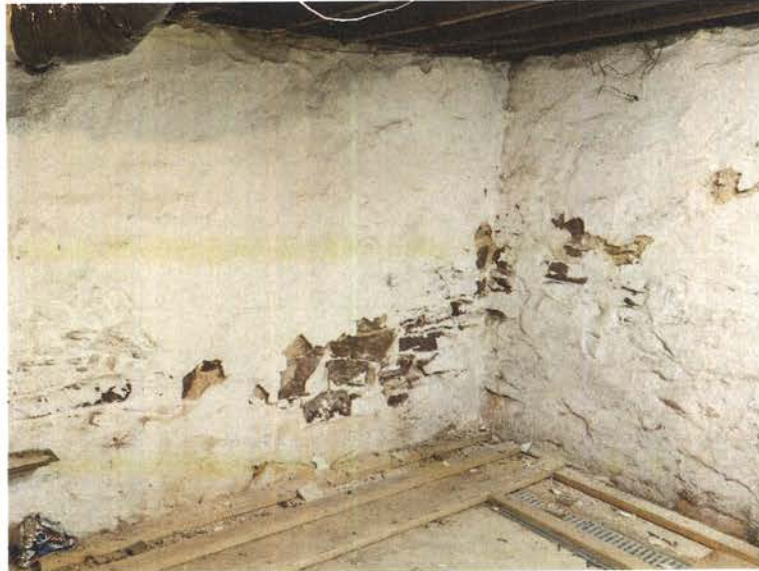
We entered part of the basement through the staircase access on the first floor. This staircase provided access to the north-west rear corner of the basement which was approximately one-quarter of the building's footprint. The foundation was made up of flagstone foundation walls with mortared joints. The inside face of the foundation walls had parging installed at one time with white paint. A slab on grade was installed within this space and the bottom of the foundation walls all appeared to go below this slab on grade.

Photograph 1: Parging delaminating from the flagstone foundation wall

The existing foundation walls appear to be in adequate condition and require only minor structural repairs such as repointing mortar joints and repairing some of the larger openings which were made for duct penetrations.

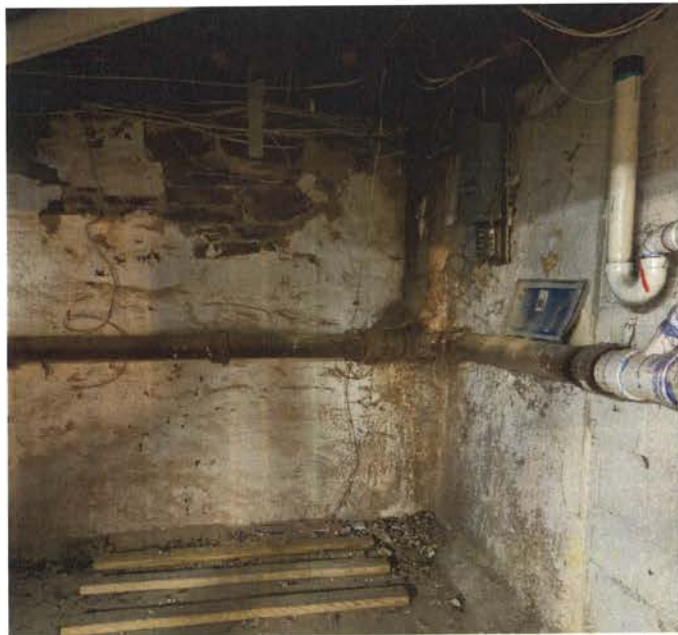
Within this space, there were some signs of moisture infiltration previously in the space (water staining on the slab and walls). However, at the time of our site visit, there were no active water infiltration.

Photograph 2: Signs of water infiltration and parging delamination

There were a few localized locations on the wall where water infiltration likely loosened the parging on the flagstone wall which has caused the parging to break loose. From the exposed flagstone foundations, the stone and mortar appeared to be in adequate condition with no signs of movement within the wall. Significant water infiltration through the wall typically results in softened and eroded mortar joints.

The water infiltration issue at the exterior walls can be addressed from the exterior of the building, by regrading and providing proper channels for the water to penetrate the surrounding soil away from the building.

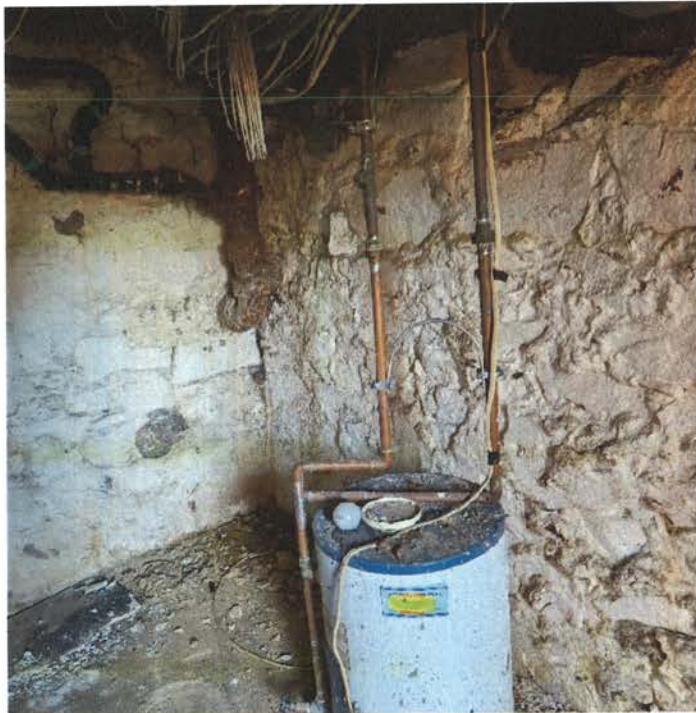
Access to the remaining portion of the basement was gained by a side Bilco door on the north-east side of the building. This door provided access to the remaining portion of the basement. The North corner of the basement appears to be where the bulk of the building utilities are located, including the electrical panel, hot water heaters and HVAC. This portion of the basement foundation wall was the same as previously observed, with flagstone foundation walls and a slab on grade. The walls appeared to be in adequate condition with no signs of wall movement or damage.

Photograph 3: Flagstone foundation wall adjacent to bilco access

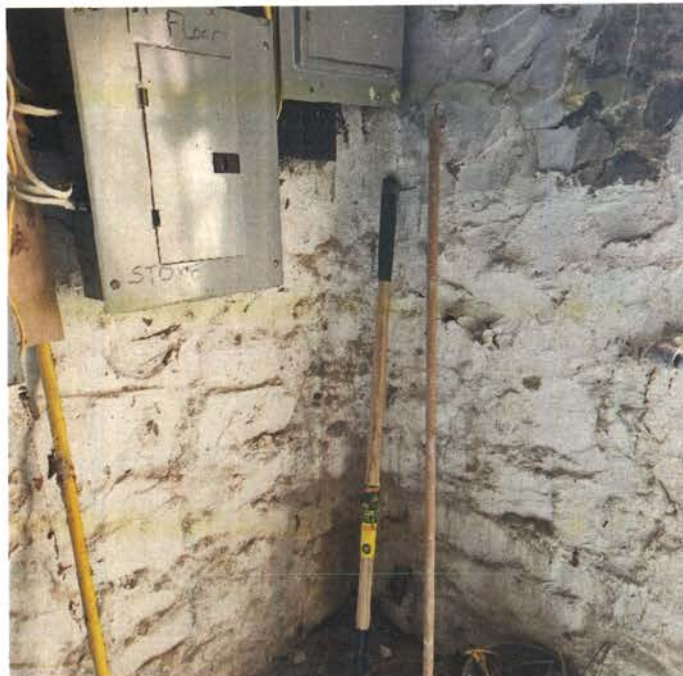
Photograph 4: Flagstone foundation wall adjacent to bilco access

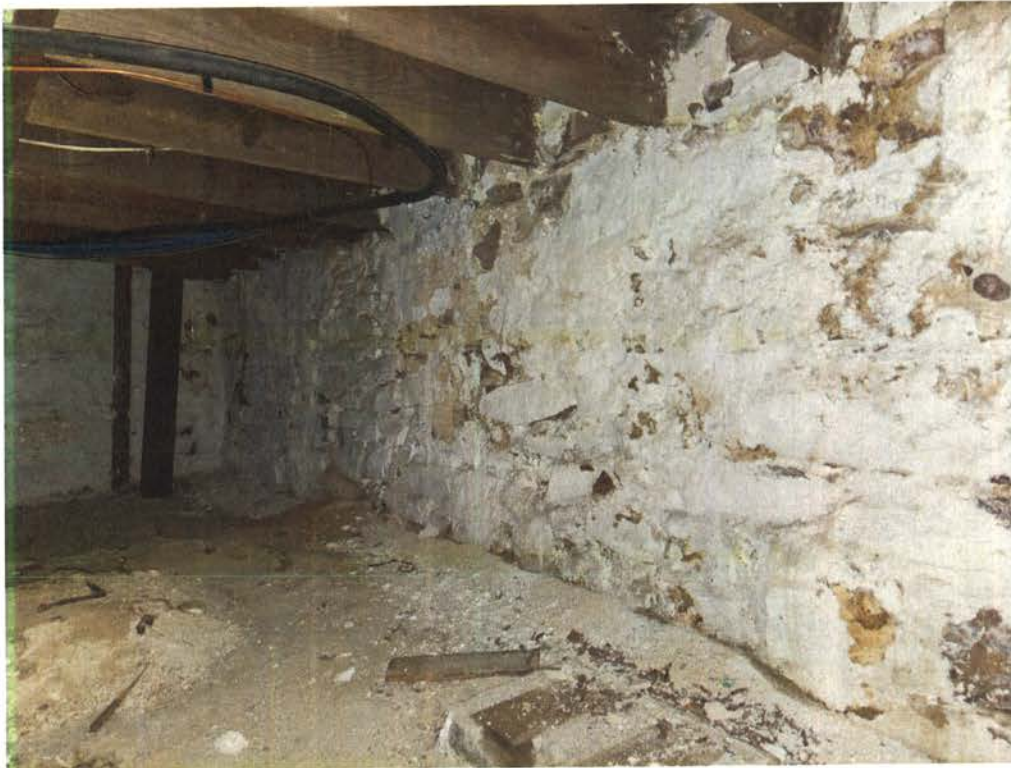
From this corner of the basement, walking to the front of the building, there is a step down to a dirt floor. This step down is a result of a partial dugout basement. The dugout portion of the basement is mostly localized to the middle of the building. There is a middle bearing flagstone foundation wall splitting the left and right sides of the building with a few openings within the wall to allow travel between the two sides. On the right side of this basement area, the original grade is still intact with a step down approximately 4 feet off the face of the foundation wall. This foundation wall appears to be in adequate shape with no signs of movement or damage.

Photograph 5: Flagstone foundation wall with original basement floor

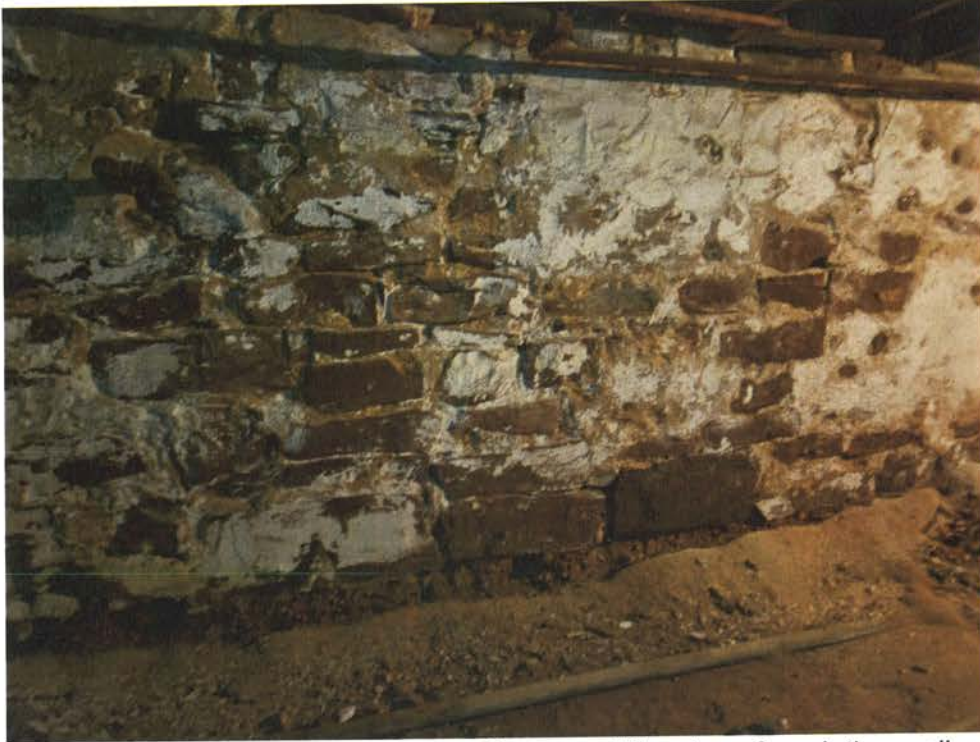
Along the left and middle foundation walls, there are portions of the dugout basement which are directly adjacent to these walls, exposing the earth below the foundation wall. On the left foundation wall, this length is approximately 11 feet. At the middle foundation wall, it appears concrete was poured against the exposed earth under the foundation wall. Despite the dugout portion of the basement floor adjacent to these walls, there did not appear to be any visible movement in the flagstone foundation walls throughout the basement.

Photograph 6: Portion of exposed bottom of flagstone foundation wall

The original flagstone foundation walls show little to no sign of movement and the mortared joints appear in adequate condition with minor signs of degradation. The local areas of soil excavations directly adjacent to the foundation walls have not yet disturbed the soil directly underneath the foundation walls. However, due to this exposure, we recommend that this issue be addressed immediately. This can be addressed by back-filling and recompacting these excavated areas, or by pouring a new structurally detailed concrete curb, to hold back the soil under the foundation walls.

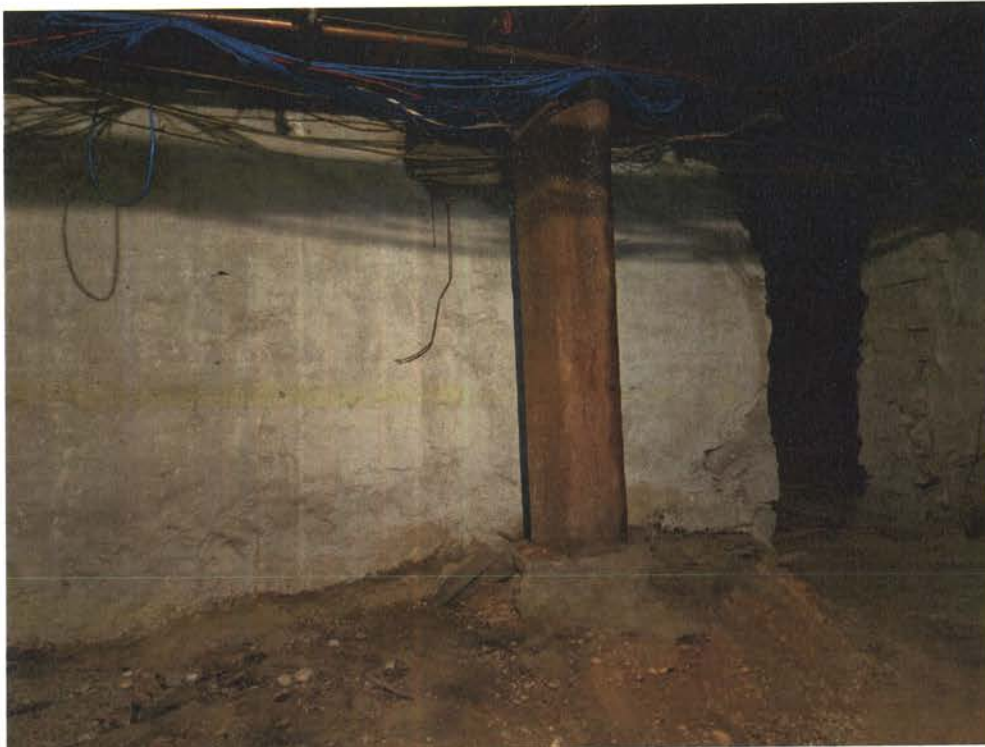
Directly adjacent to the middle foundation wall, there is a post which supports a column from the floor above. The footing under this post is exposed due to the dugout basement and is currently in an unstable position.

Photograph 7: Undersized and exposed column footing

The column adjacent to the middle bearing wall will require a new footing to be poured to properly support the building loads from above.

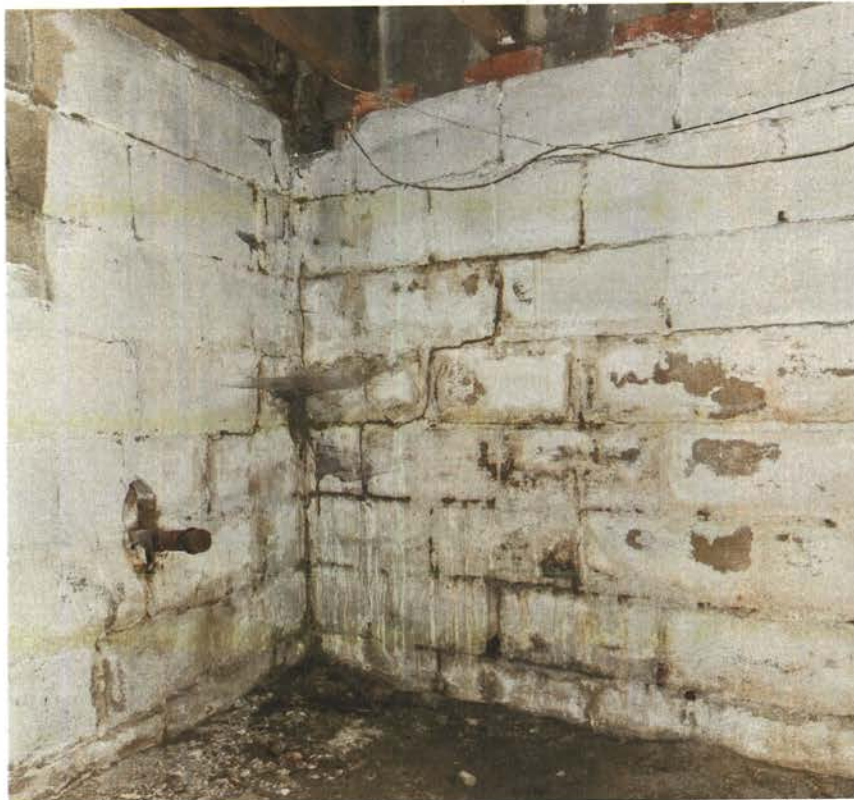
The front portion of the basement was an addition that was added after the original construction. This portion of the foundation wall is constructed out of concrete masonry units (CMU). This CMU appears to be unreinforced and hollow and shows some evidence of movement at the top course along with gaps within the mortar construction.

Photograph 8: Front CMU foundation wall with water infiltration and step cracking

The front CMU wall will likely require some areas of repointing and potentially grouting the hollow cells to restrain any future movement of the block wall.

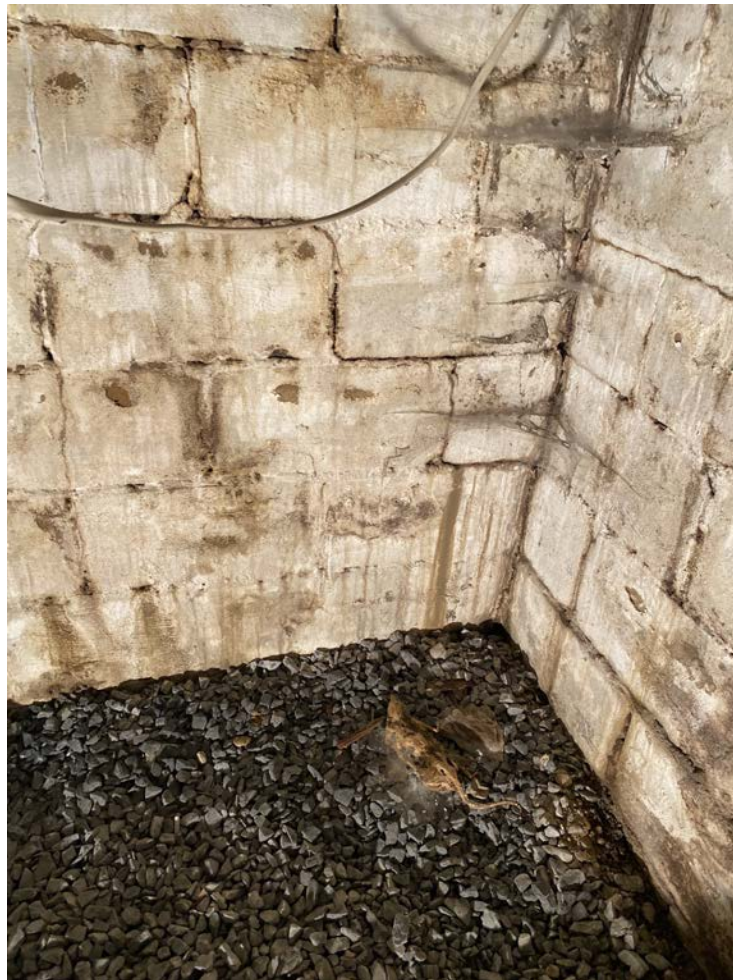
Foundation. There are signs of water infiltration around the foundations. This water infiltration is caused by poor drainage and the soil conditions around and under the foundation. Water infiltration introduced into previously consolidated soil can induce secondary consolidation of the soil that will result in movement of the foundation.

Underpin. The process of underpinning involves excavating small sections underneath the existing foundation footer to a depth that could better provide the necessary soil bearing capacity to support the structure on top of it. Typically a new footer is poured using reinforced concrete inside of the earthen form created by the excavation.

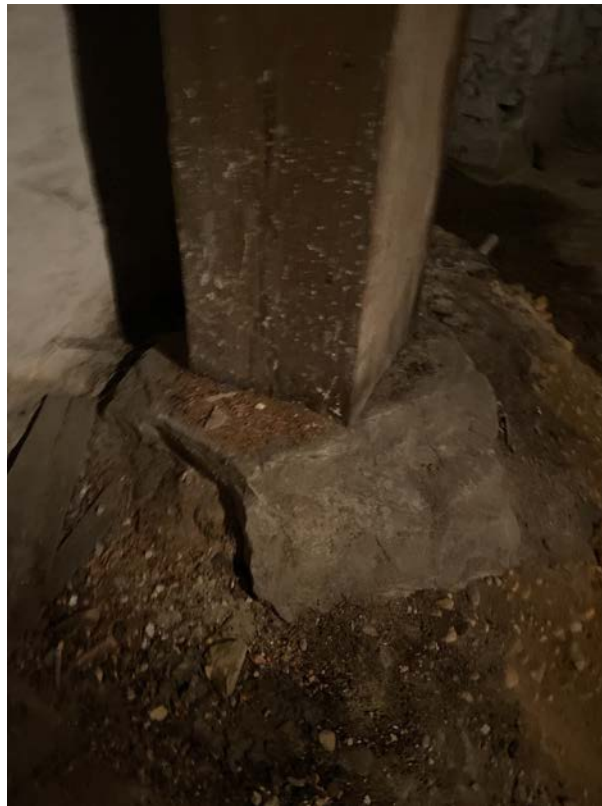
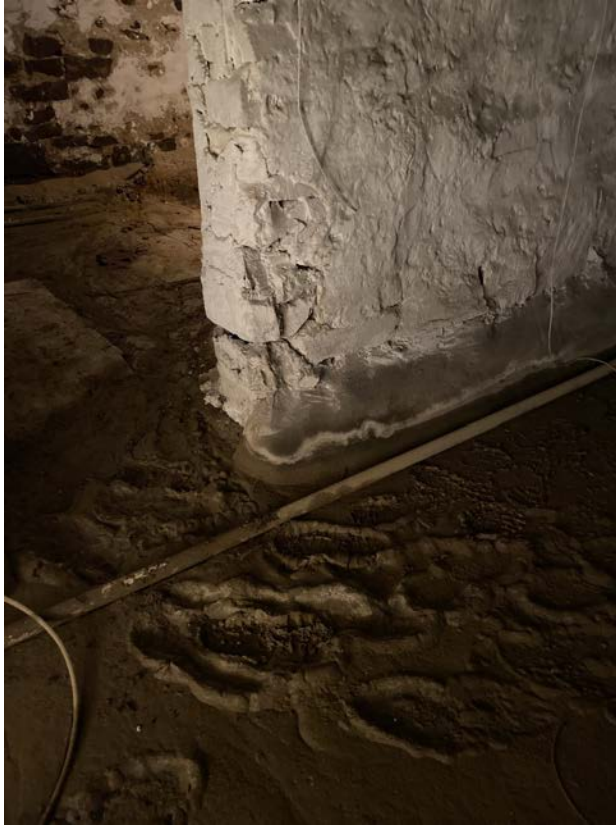
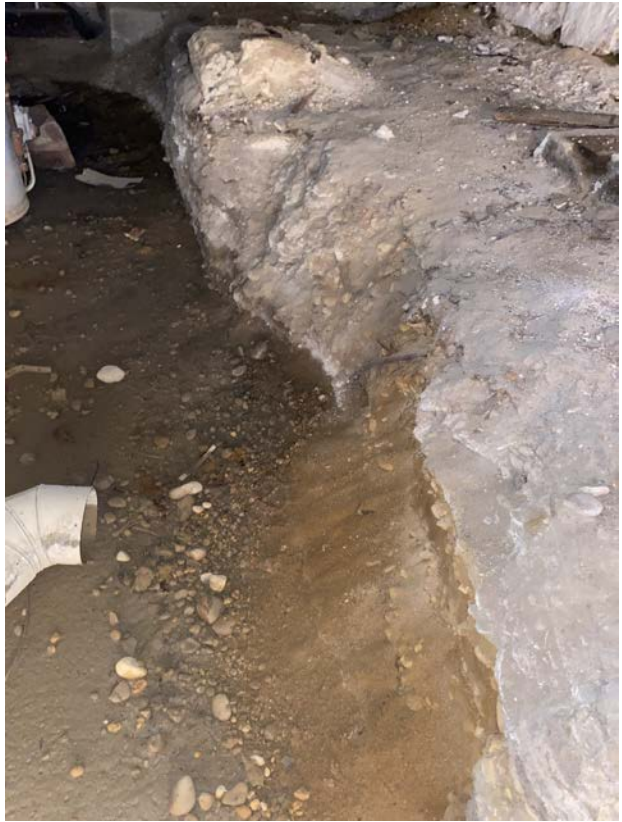
Foundation Undermined. Certain portions of the foundation for the building were undermined and are now unstable. Additionally the foundation for one of the main support columns was also undermined.

1. **Underpin.** Underpin the foundation walls to the desired depth. The process of underpinning involves excavating small sections underneath the existing foundation footer to a depth that could better provide the necessary soil bearing capacity to support the structure on top of it. Typically a new footer is poured using reinforced concrete inside of the earthen form created by the excavation.
2. **Benching.** Benching the foundation would include pouring a 1'x1' reinforced concrete bench around the perimeter of the basement to provide the exposed soil with lateral stability.

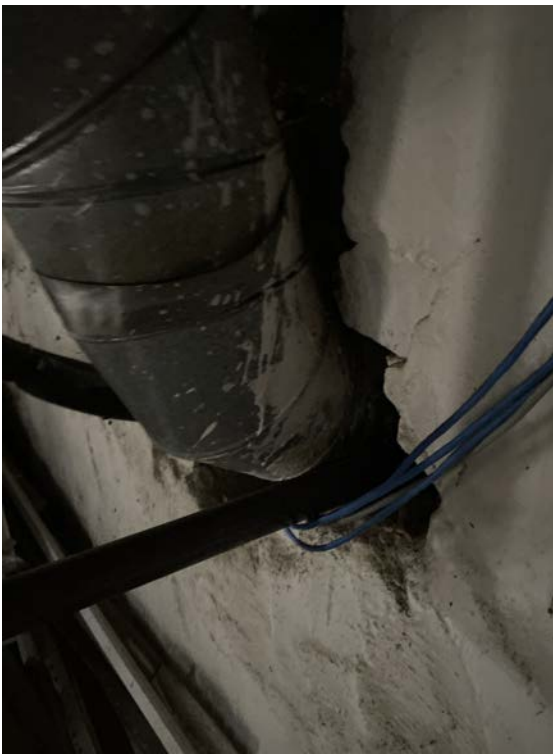
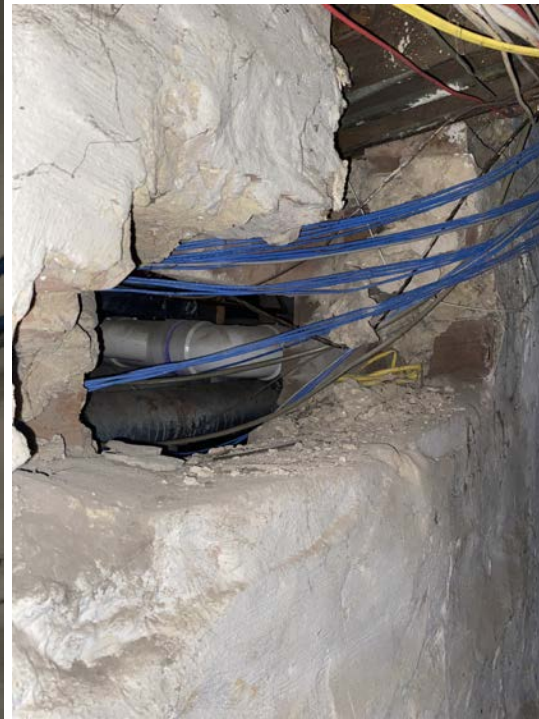
Foundation Damage There are large holes in the foundation wall. These holes are the result of the installation of various mechanical, electrical and plumbing systems. These holes greatly affect the integrity of the foundation.

Patch. Clean out the debris from the failing foundation wall. Install 3-#4 reinforcement bars going each way. Ensure the reinforcement bar is embedded into the adjacent wall a minimum of 3". Then form up the hole for concrete to be poured.

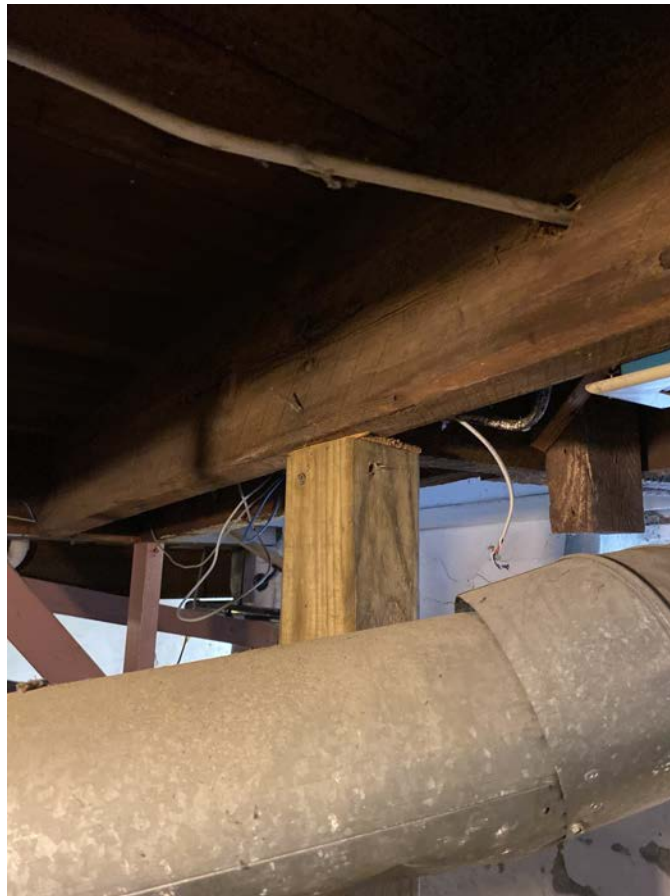
Beam Deflection. There is a beam installed in the basement which was intended to support the floor joists above it due to the floor sagging. This beam is deflecting for its purpose because of overload and deterioration.

Post/Footer. Support the mid-span of each beam section with a 4" steel column (HSS4x0.313) on top of a 24"x24"x12" reinforced concrete footer with 4-#4 reinforcement bars going each way. This new column should be connected to the existing beam and new footer with 4-½" steel bolts.

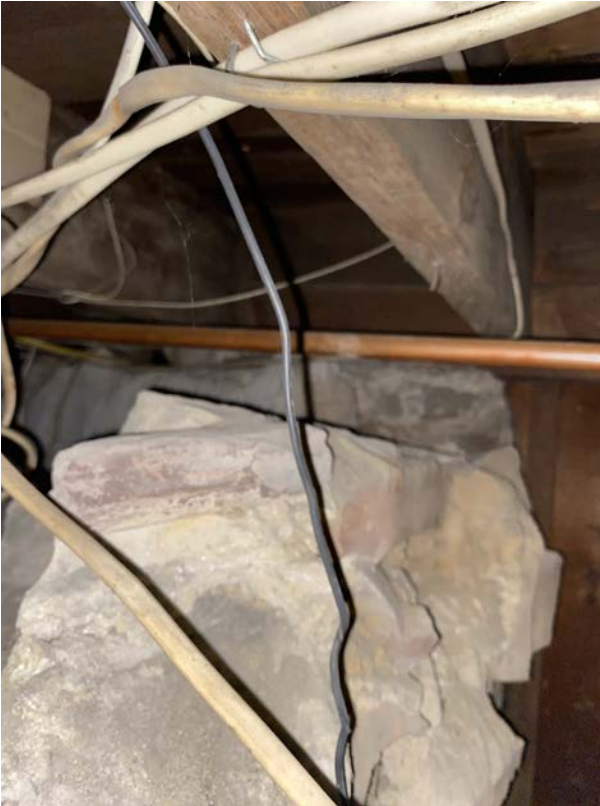
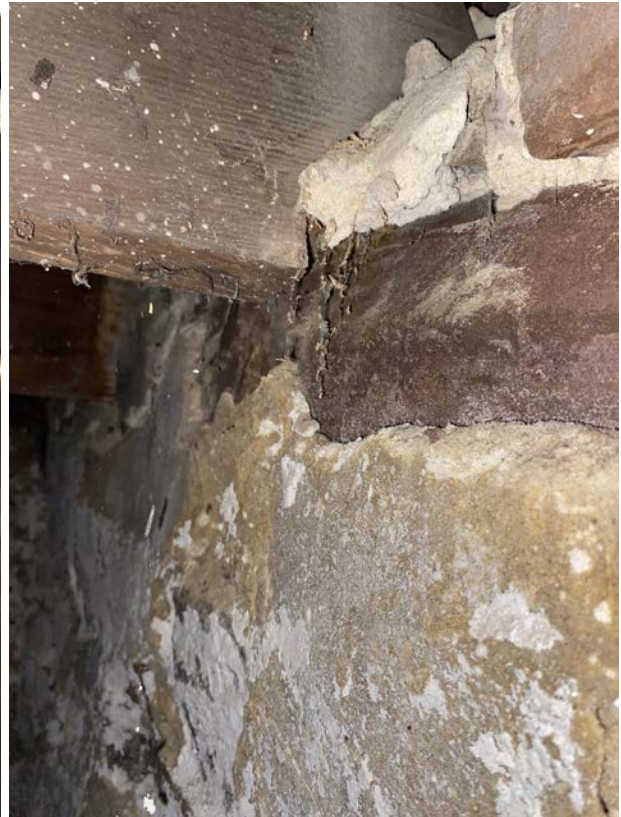
Joists Bearing Failure. The joists on the sides of the basement are compressing where they rest on the exterior wall. This type of failure is called a bearing failure and is the result of water infiltration on the exterior wall that is damaging the joists and causing it to compress. As a result of this compression the floors above the joists are starting to deflect and sag.

1. **Ledger.** Install a 2-2x12 ledger under the joists that are failing and attach the ledger to the wall using $\frac{3}{4}$ " bolts epoxy anchored into the foundation.
2. **Beam/Column/Footer.** Install a 2-2"x12" Beam under the deflecting joists where they rest on the exterior wall that spans a maximum of 10' The beam should be supported on either side by a 4" steel post on top of a 20"x20"x10" concrete footer with 3-#4 reinforcement bars going each way.

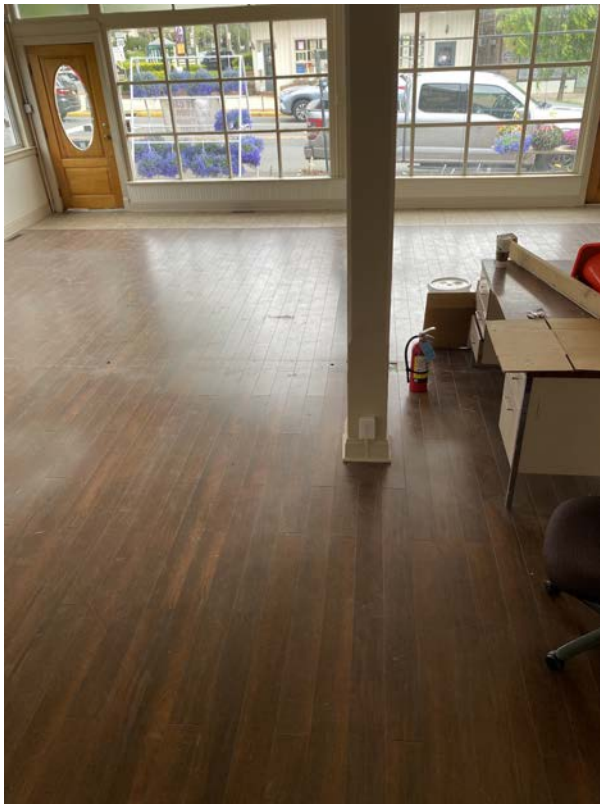
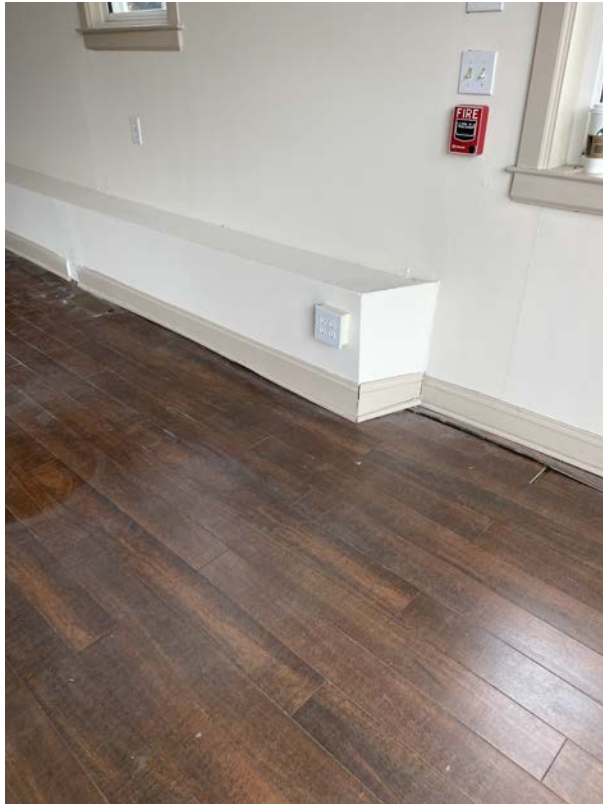
Joist Deflection (Sagging). The 1st floor joists are deflecting and causing the floor above it to sag. This deflection is the result of damage and/or overloading due to the installation of various mechanical and plumbing systems. As a result the structural integrity of the damaged joists have been compromised and will need to be reinforced.

Sister. Sister any joists that are deflecting. Deflection can be detected by horizontal cracks in the middle of the joist. Also sister any joists that are damaged. Sistering joists requires that a new wood joist be attached to the damaged joists in order to reinforce the area that is compromised. Sister the damaged joists with 2"x members that match the depth of the existing members. The sisters should be attached using 1/2" bolts every 1' staggered top and bottom or with large construction screws meant for sistering. The new sister should run the entire length or as far as practical of the damaged joist.

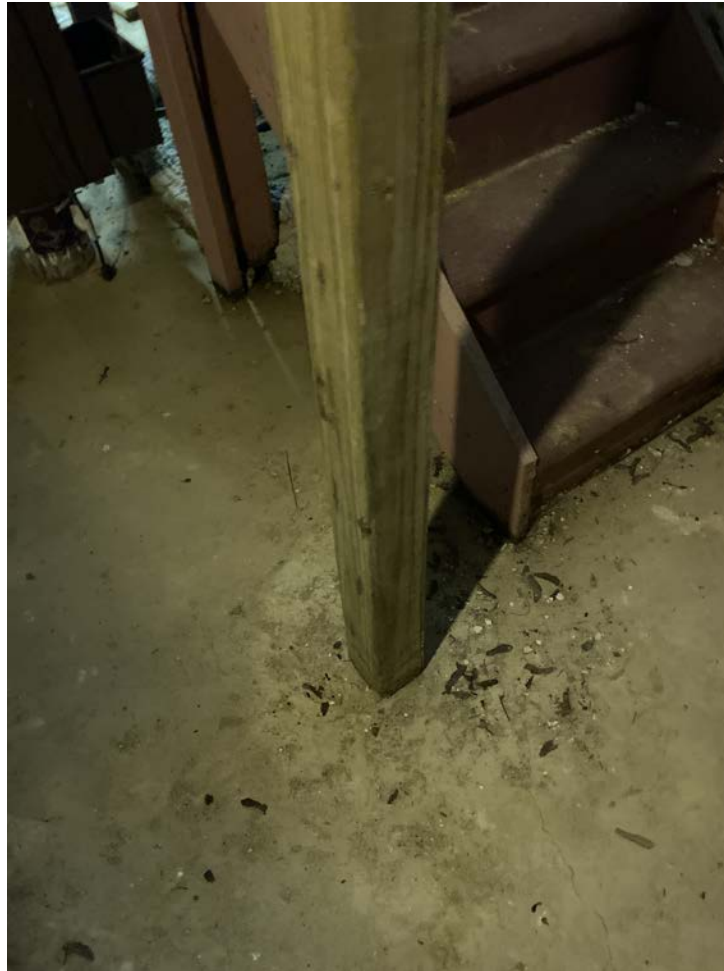
Stair Header Undersized. The header for the stairs leading to the basement is undersized and starting to sag as a result. Stair headers are natural weak spots in the framing of any floor and need to be supported properly. If not supported properly the wood members around the header will begin to sag over time.

Column/Footer. Reinforce the stair header with a column on top of a reinforced concrete footer. Support the corners of the stair header with 4" steels posts on top of 16"x16"x6" concrete footers with 3-#4 reinforcement bars going each way. The post cap and bottom should be a 1/2" steel plate with 4-1/2" bolts.

Sister. Sister the damaged joists with 2x10 members. The sisters should be attached using 1/2" bolts every 1' staggered top and bottom.
