LEAKE ENGINEERING, LLC

Project Address: 501 Station Ave, Haddon Heights, NJ 08035

Date: 05/12/2022

Engineer Evaluation. This inspection was completed on 05/11/2022 at the request of the owner to investigate possible structural issues observed.

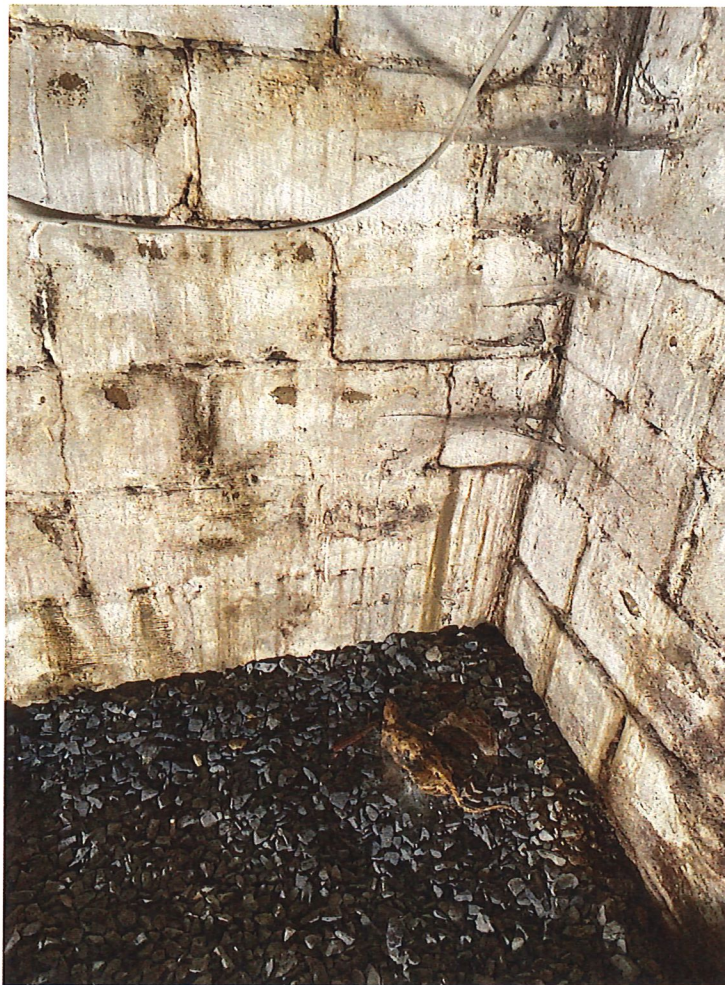
Foundation. There are signs of water infiltration around the foundations. This water infiltration is caused by poor drainage and the soil conditions around and under the foundation. Water infiltration introduced into previously consolidated soil can induce secondary consolidation of the soil that will result in movement of the foundation.

Underpin. The process of underpinning involves excavating small sections underneath the existing foundation footer to a depth that could better provide the necessary soil bearing capacity to support the structure on top of it. Typically a new footer is poured using reinforced concrete inside of the earthen form created by the excavation.

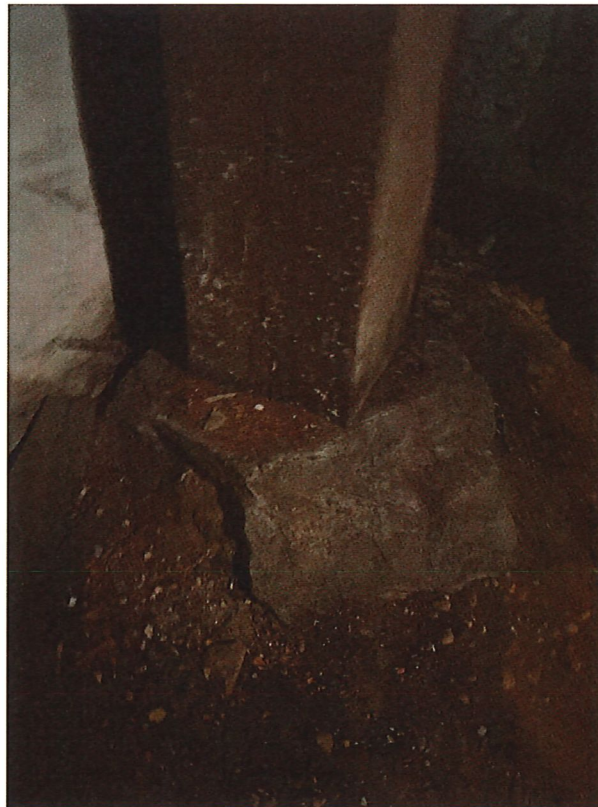
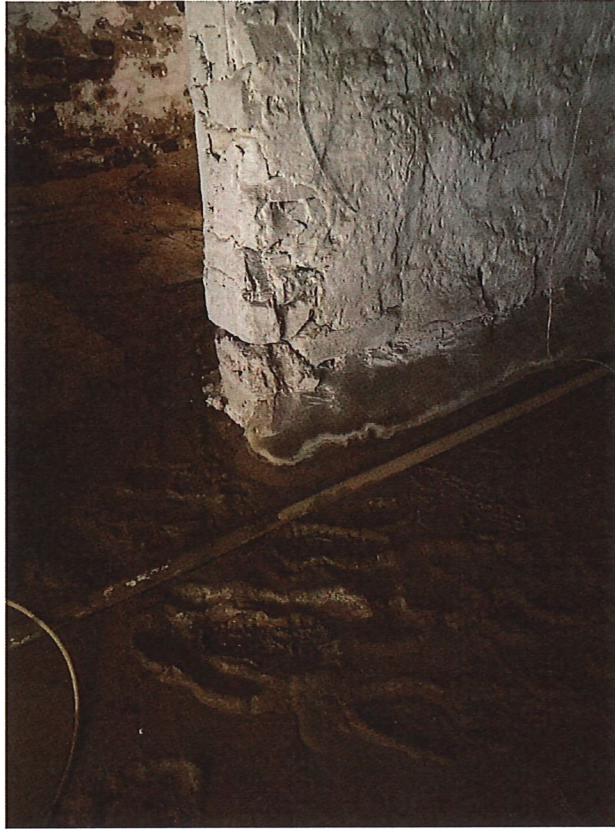
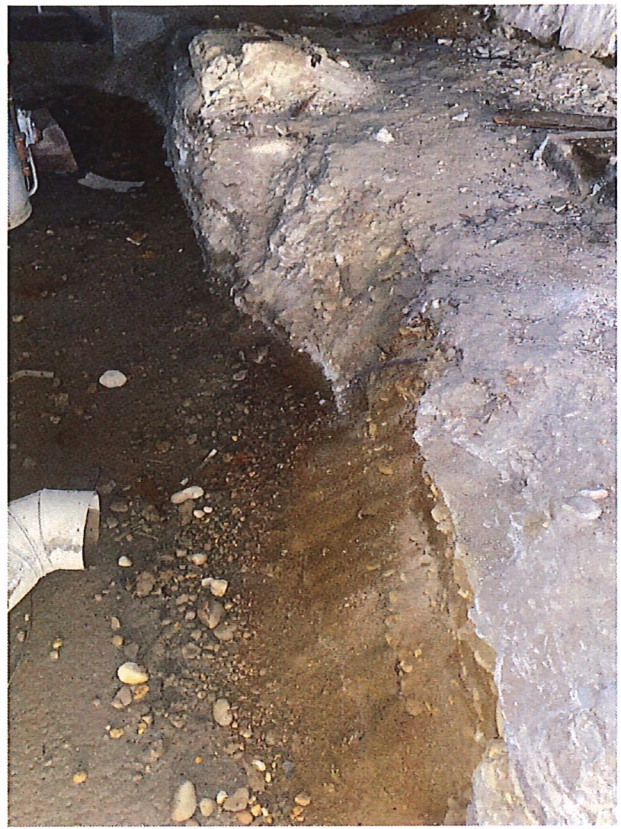
Foundation Undermined. Certain portions of the foundation for the building were undermined and are now unstable. Additionally the foundation for one of the main support columns was also undermined.

1. **Underpin.** Underpin the foundation walls to the desired depth. The process of underpinning involves excavating small sections underneath the existing foundation footer to a depth that could better provide the necessary soil bearing capacity to support the structure on top of it. Typically a new footer is poured using reinforced concrete inside of the earthen form created by the excavation.
2. **Benching.** Benching the foundation would include pouring a 1'x1' reinforced concrete bench around the perimeter of the basement to provide the exposed soil with lateral stability.

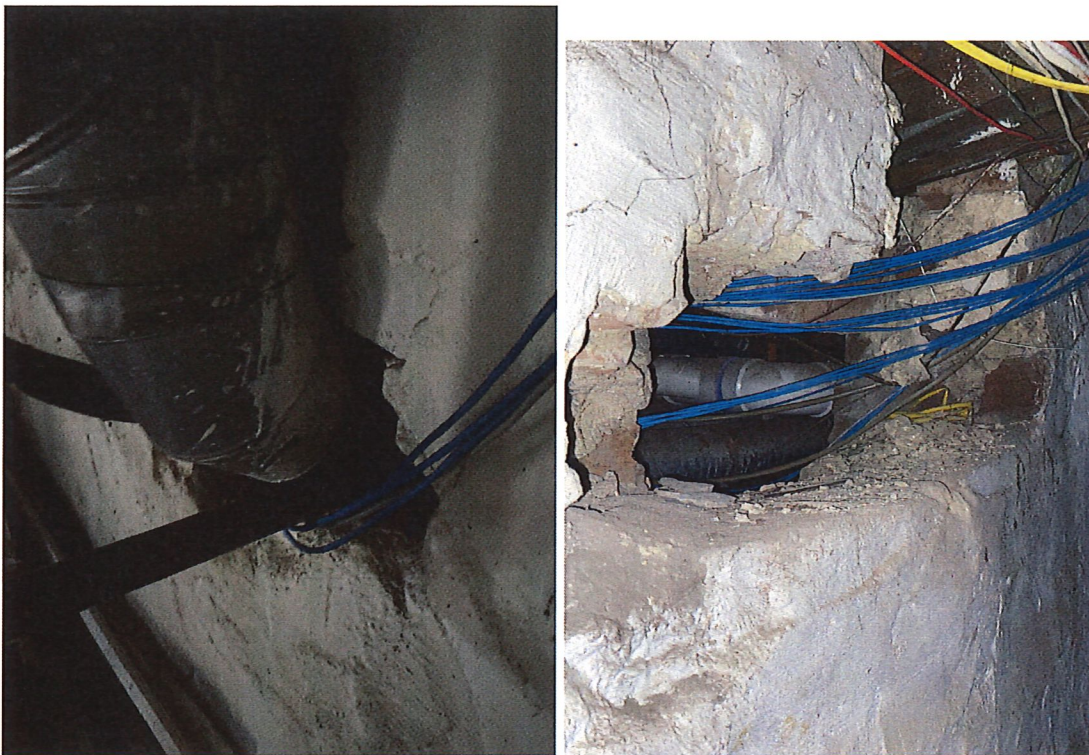
Foundation Damage There are large holes in the foundation wall. These holes are the result of the installation of various mechanical, electrical and plumbing systems. These holes greatly affect the integrity of the foundation.

Patch. Clean out the debris from the failing foundation wall. Install 3-#4 reinforcement bars going each way. Ensure the reinforcement bar is embedded into the adjacent wall a minimum of 3". Then form up the hole for concrete to be poured.

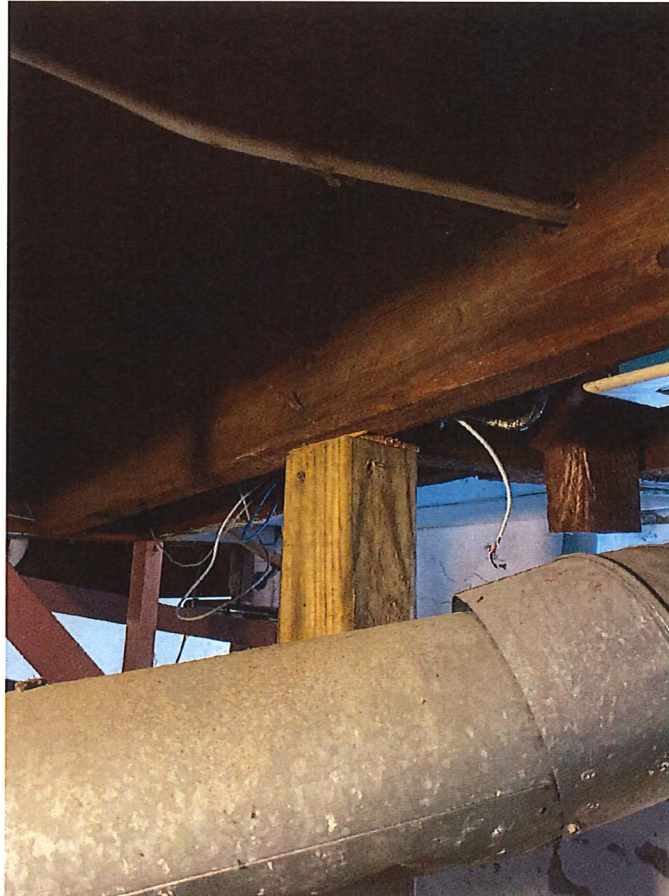
Beam Deflection. There is a beam installed in the basement which was intended to support the floor joists above it due to the floor sagging. This beam is deflecting for its purpose because of overload and deterioration.

Post/Footer. Support the mid-span of each beam section with a 4" steel column (HSS4x0.313) on top of a 24"x24"x12" reinforced concrete footer with 4-#4 reinforcement bars going each way. This new column should be connected to the existing beam and new footer with 4-½" steel bolts.

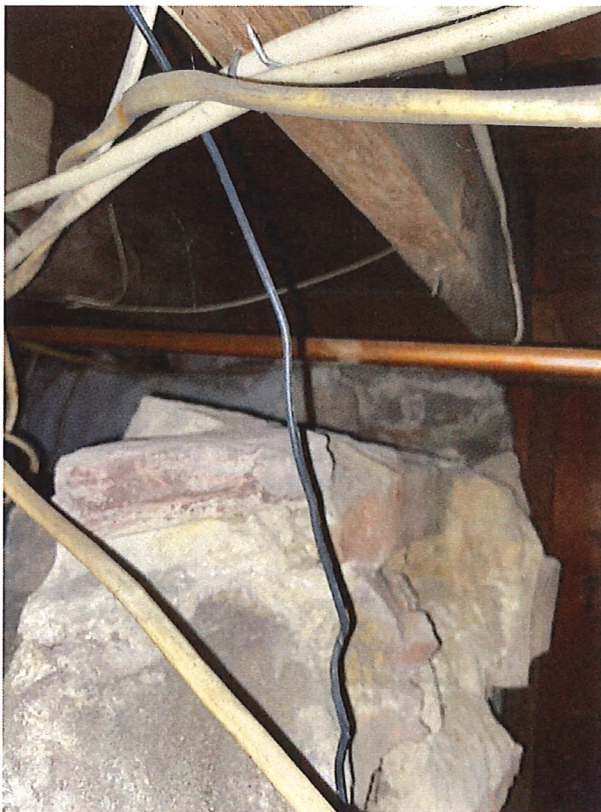
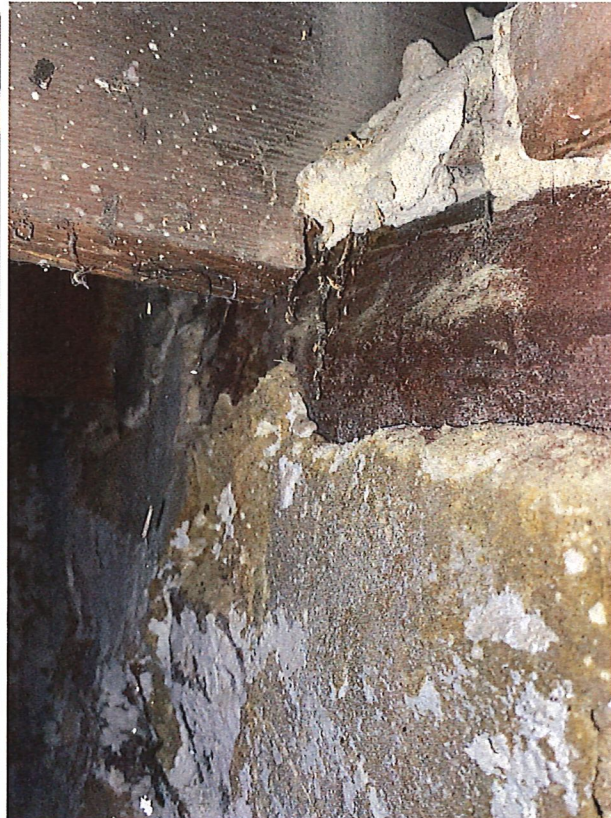
Joists Bearing Failure. The joists on the sides of the basement are compressing where they rest on the exterior wall. This type of failure is called a bearing failure and is the result of water infiltration on the exterior wall that is damaging the joists and causing it to compress. As a result of this compression the floors above the joists are starting to deflect and sag.

1. **Ledger.** Install a 2-2x12 ledger under the joists that are failing and attach the ledger to the wall using $\frac{3}{4}$ " bolts epoxy anchored into the foundation.
2. **Beam/Column/Footer.** Install a 2-2"x12" Beam under the deflecting joists where they rest on the exterior wall that spans a maximum of 10'. The beam should be supported on either side by a 4" steel post on top of a 20"x20"x10" concrete footer with 3-#4 reinforcement bars going each way.

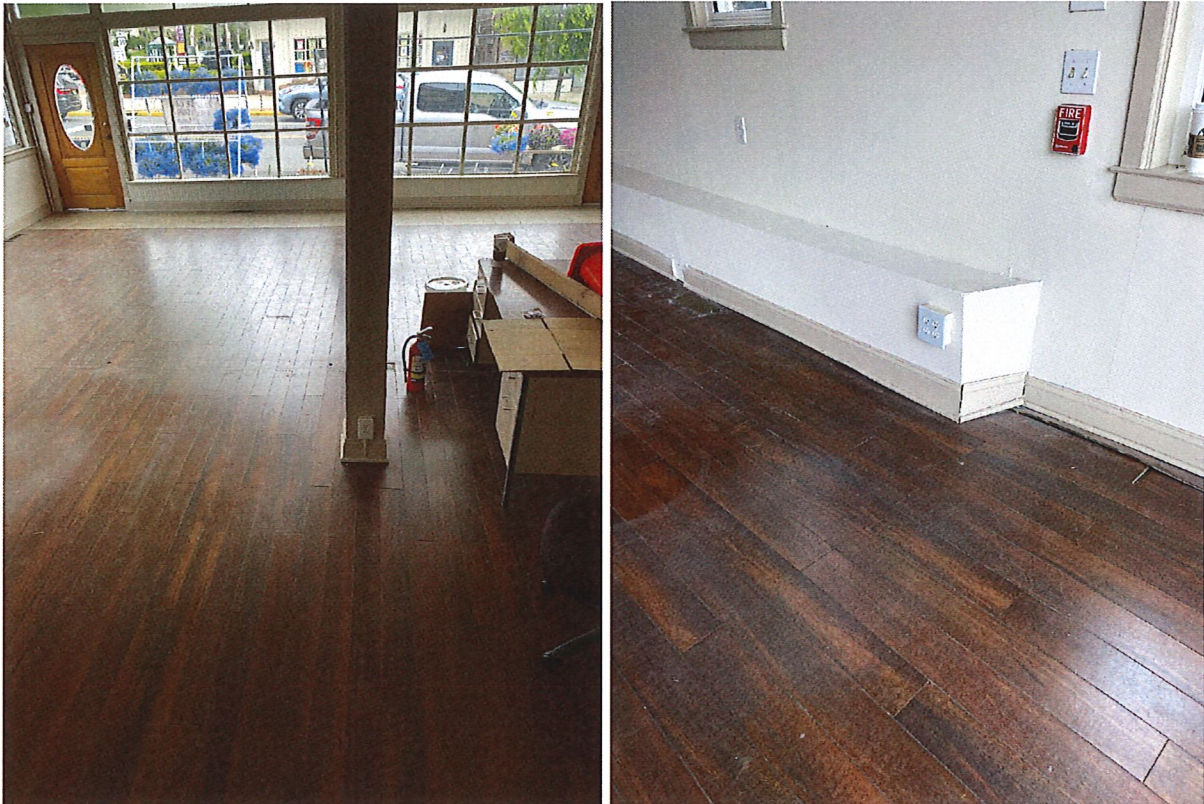
Joist Deflection (Sagging). The 1st floor joists are deflecting and causing the floor above it to sag. This deflection is the result of damage and/or overloading due to the installation of various mechanical and plumbing systems. As a result the structural integrity of the damaged joists have been compromised and will need to be reinforced.

Sister. Sister any joists that are deflecting. Deflection can be detected by horizontal cracks in the middle of the joist. Also sister any joists that are damaged. Sistering joists requires that a new wood joist be attached to the damaged joists in order to reinforce the area that is compromised. Sister the damaged joists with 2"x members that match the depth of the existing members. The sisters should be attached using ½" bolts every 1' staggered top and bottom or with large construction screws meant for sistering. The new sister should run the entire length or as far as practical of the damaged joist.

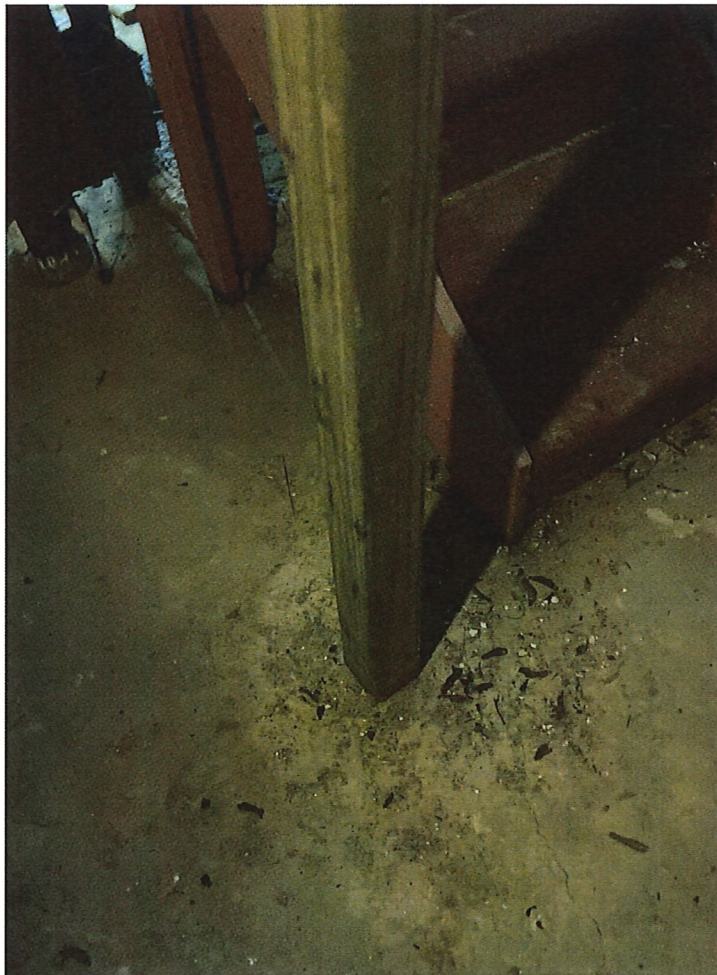
Stair Header Undersized. The header for the stairs leading to the basement is undersized and starting to sag as a result. Stair headers are natural weak spots in the framing of any floor and need to be supported properly. If not supported properly the wood members around the header will begin to sag over time.

Column/Footer. Reinforce the stair header with a column on top of a reinforced concrete footer. Support the corners of the stair header with 4" steels posts on top of 16"x16"x6" concrete footers with 3-#4 reinforcement bars going each way. The post cap and bottom should be a ½" steel plate with 4-½" bolts.

Sister. Sister the damaged joists with 2x10 members. The sisters should be attached using ½" bolts every 1' staggered top and bottom.
